# DELTA Test Report

## Seismic Test of Test Tavle

### Performed for Løgstrup A/S

DANAK-19/14413

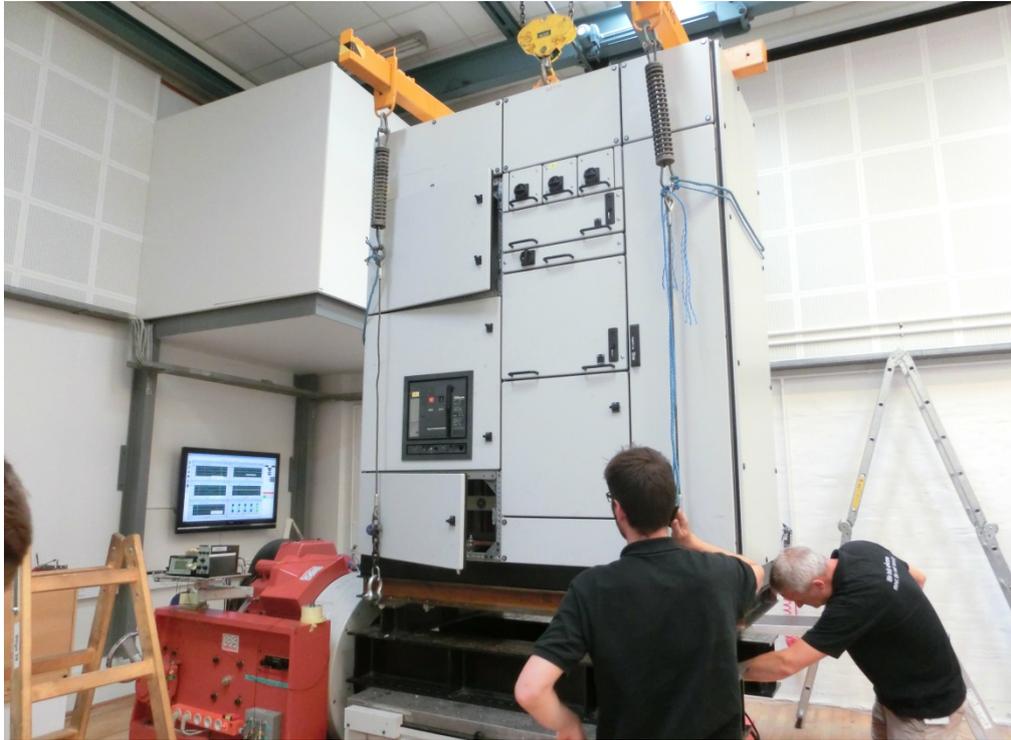
-	Brief external visual inspection	No remarks
Y	Seismic sine sweep	Performed as specified except that the lower frequency limit was 3.6 Hz (specified to 1 Hz) No damaged to the test object observed during the exposure except that 2 of the front doors opened during the exposure (see photo 9)

Photo 9 Visual Inspection after Y-axis: 2 front doors opened during exposure.

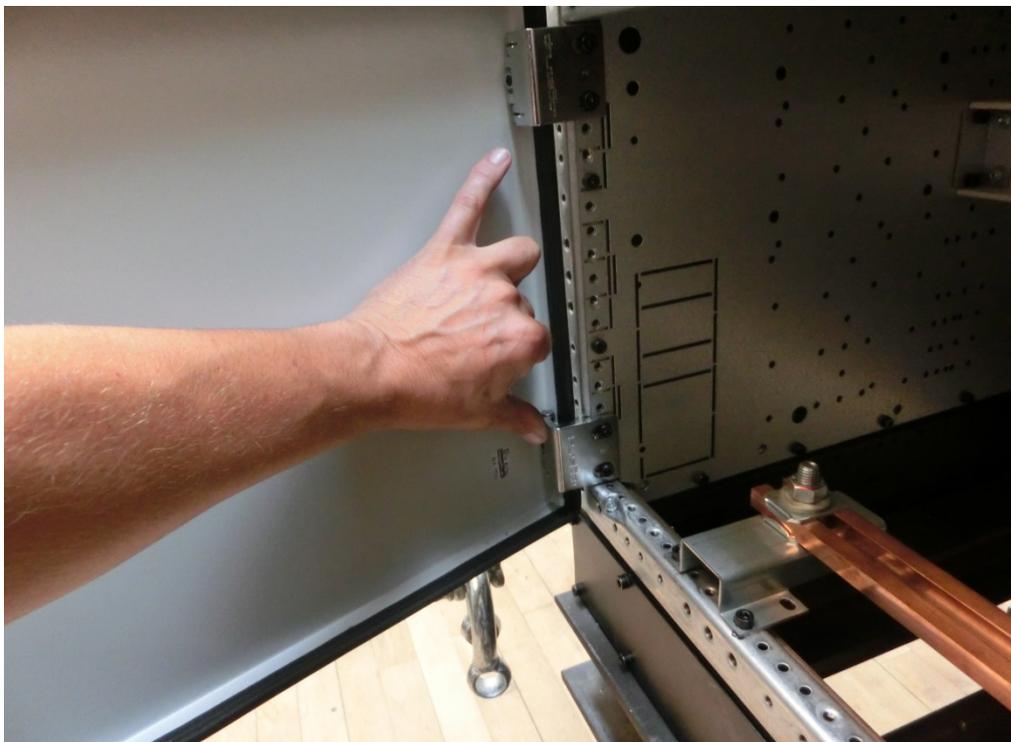
-	Brief visual inspection	Back and sides: OK 2 hinges at lower left front door loose (see photo 10) Large circuit breaker and mounting: OK Small circuit breaker and mounting OK Large cassette: One hinge partly defect (lower "pin" partly fallen out, see photo 11) No remarks to other parts

Photo 10 Visual Inspection after Y-axis: 2 front doors hinges loose.

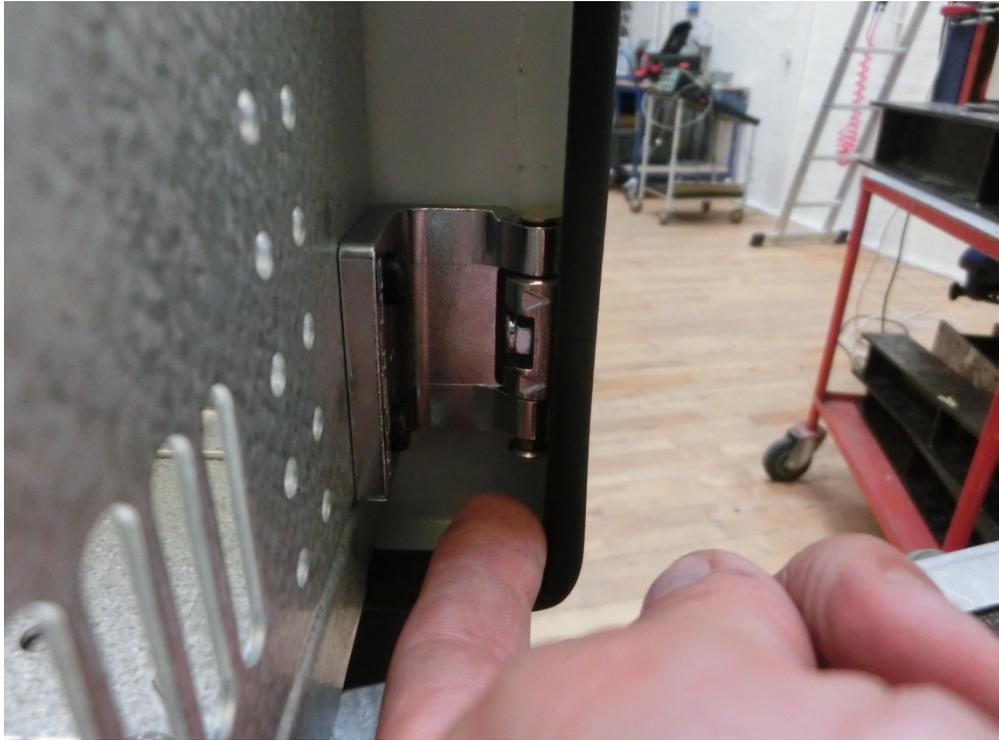
Photo 11 Visual Inspection after Y-axis: One hinge partly defect (lower “pin” fallen partly out).

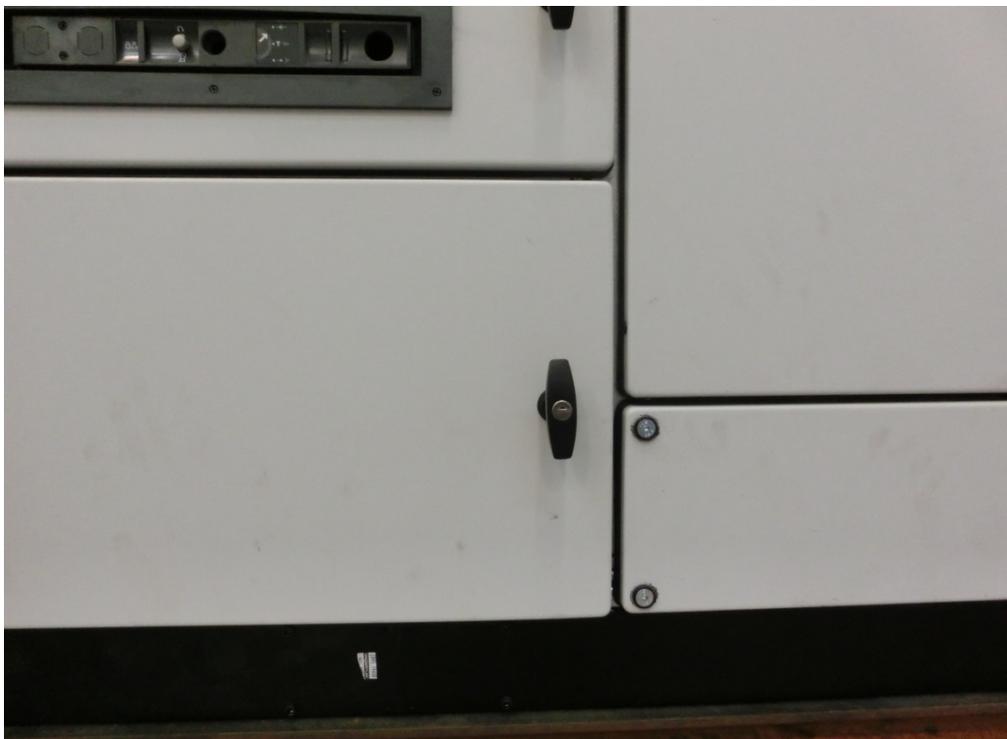
Photo 12 Modification: All front door handles changed to “T-wing” types.

-	Modification	All front door "Wing knob" handles changed to "T-wing handles" (see photo 12)
X	Seismic sine sweep	Performed as specified except that the lower frequency limit was 3.2 Hz (specified to 1 Hz) The black bottom frame was partly torn apart and one of the mounting screws at the right side plate fell off during the exposure (see photo 13+14)

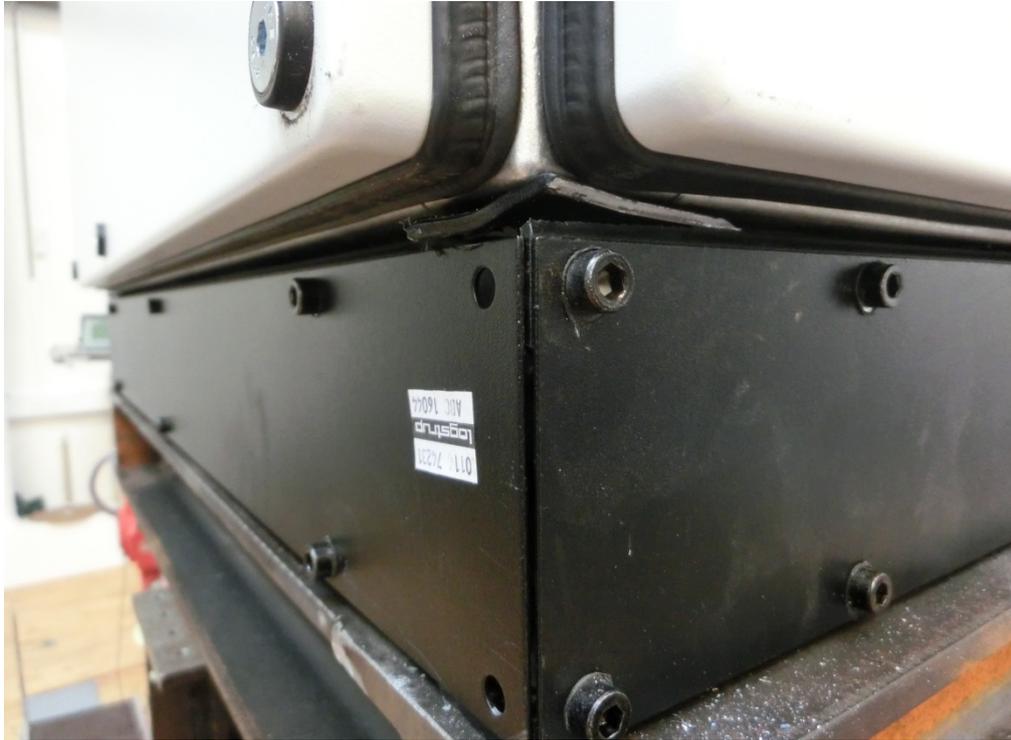
Black bottom frame partly torn apart at corners in the left side

The black bottom frame was partly torn apart.

Photo 13 Visual Inspection: Black bottom frame broken at left side.

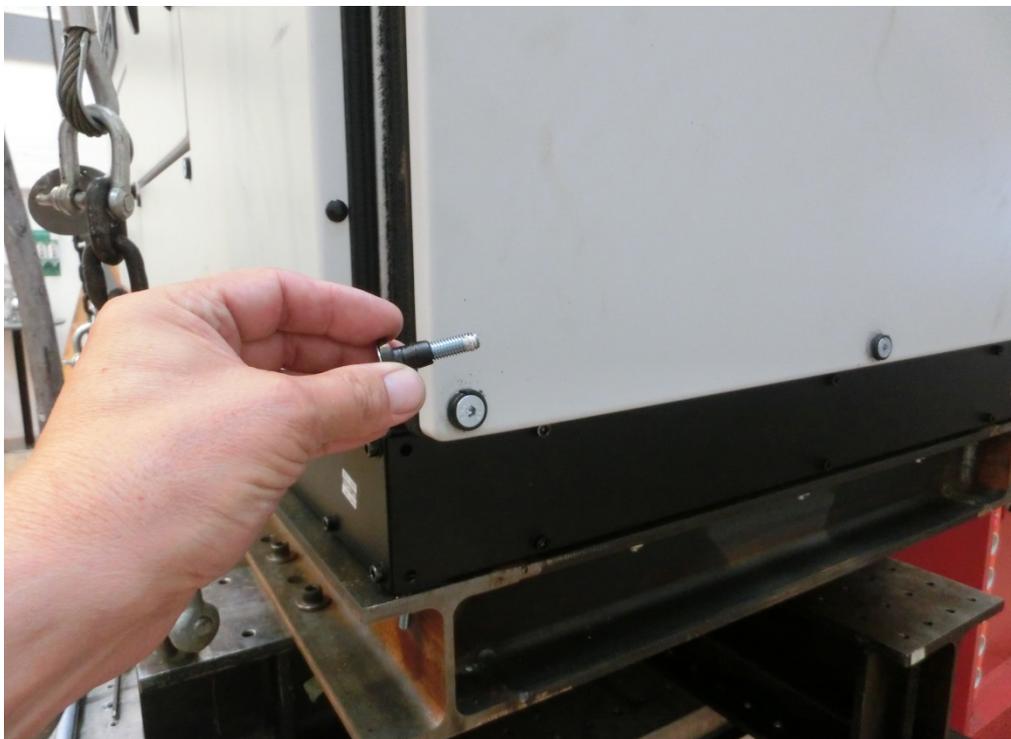
No loose side panel mounting screws at right left side (except the one that fell off during the exposure)

Photo 14 Visual Inspection: One mounting screw for right side plate fallen out.

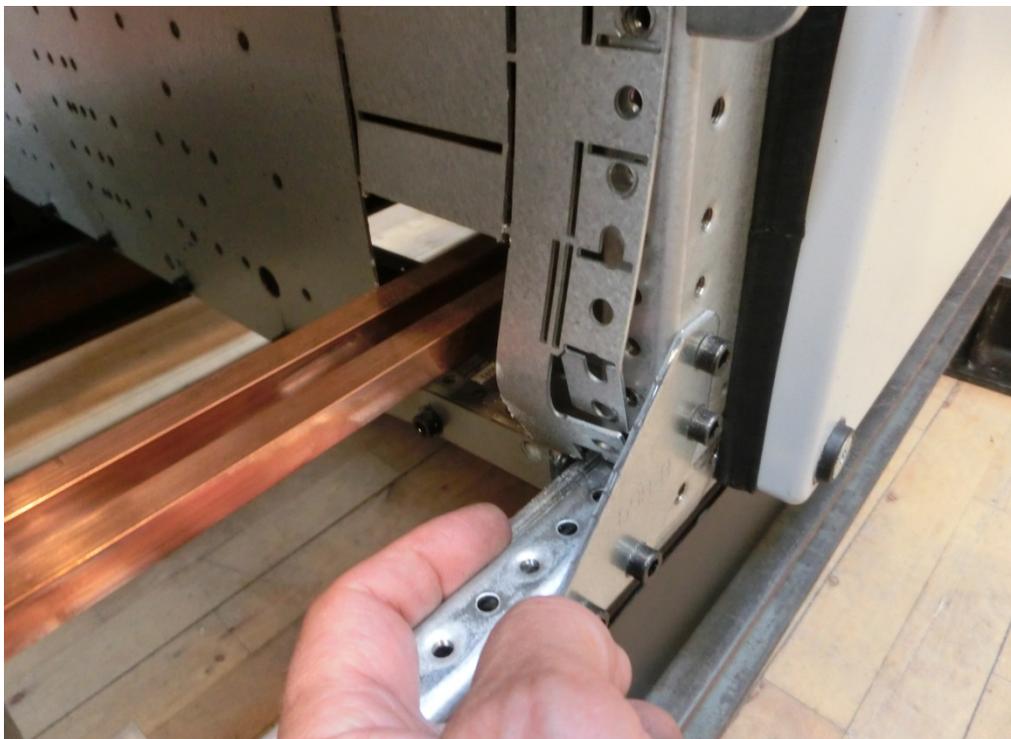
Buckling of lower right intermediate plate at front (near earth copper bars, see photo 16)

Photo 16 Visual Inspection: Buckling of lower right intermediate plate at front (near earth copper bars).

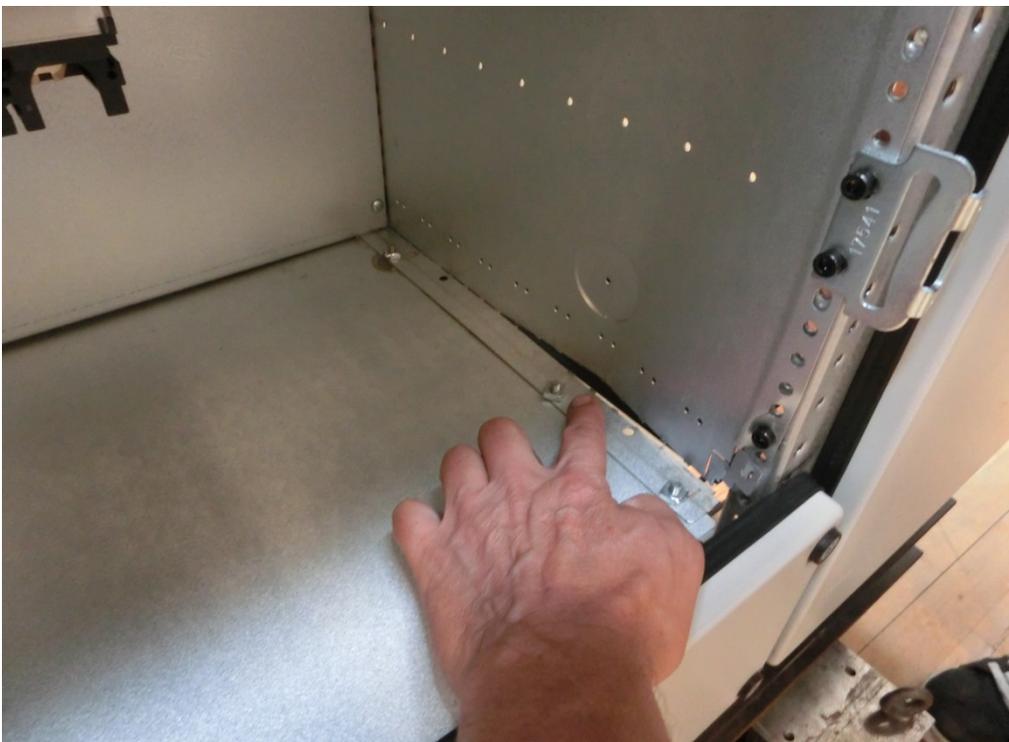
Buckling of lower cassette right side plate (in room with small circuit breaker, see photo 24)

Photo 24 Visual Inspection: Buckling of lower cassette right side plate.

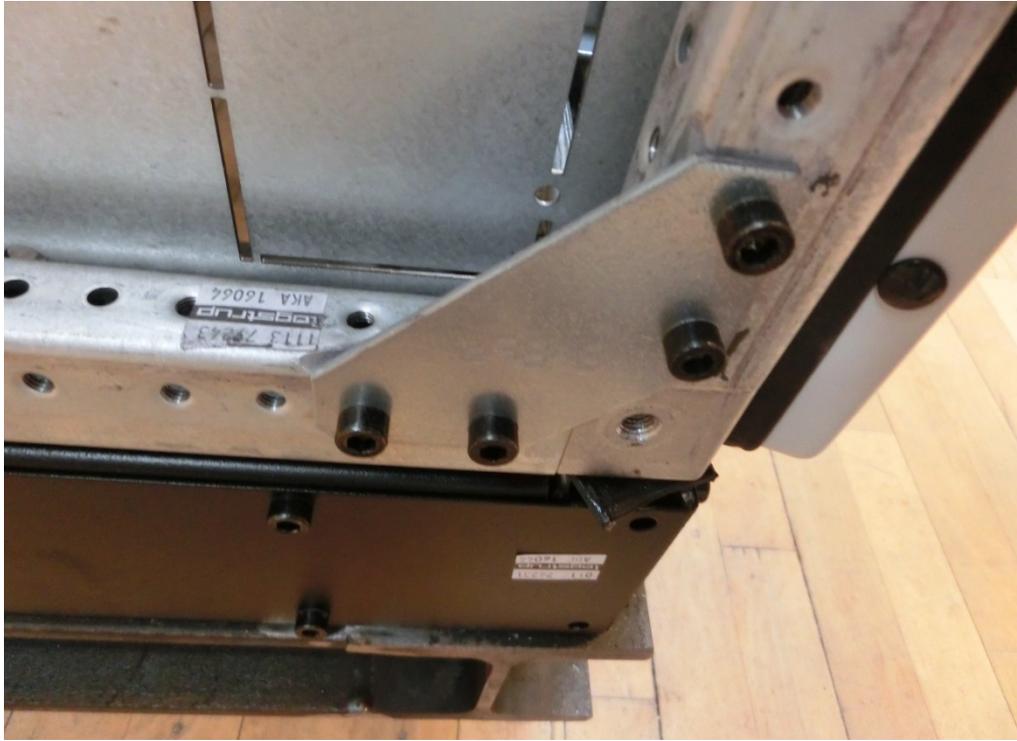
Photo 28 Visual Inspection: “Earthquake brackets” OK (black frame broken).
